# Your Inspection Report

1 ppp street  
Bramm, ON

Thursday, July 4, 2019

RE: Report No. 1013, v.3

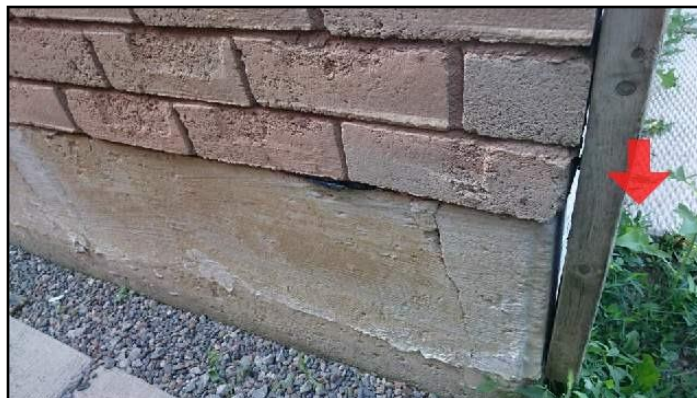
10. Brick

1. **Condition:** • Vines on building

**Implication(s):** Chance of damage to finishes | Chance of pests entering building

Recommend prune tree, vine and shrubs

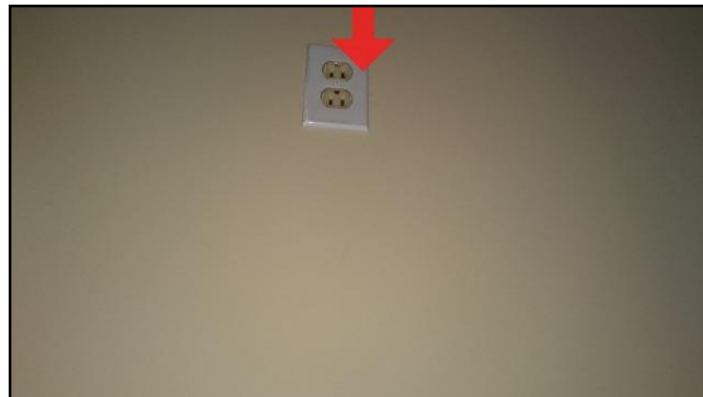
- 2. Condition: • [Inoperative](#)

**Implication(s):** Equipment inoperative

**Location:** Northeast Southwest Second Floor Bedroom

11. Inoperative

Recommend have qualified person further evaluate and replace

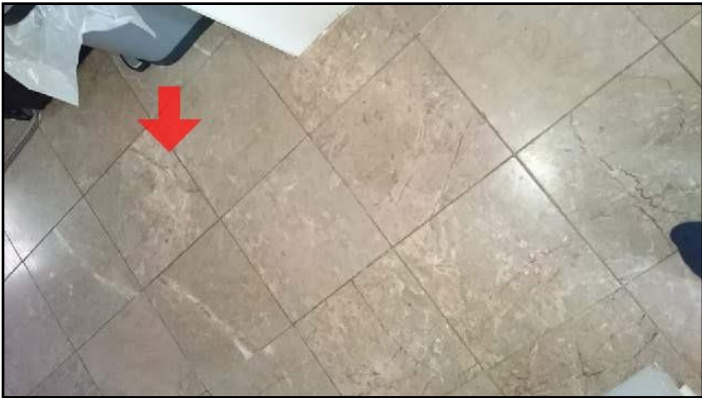
#### 5. Condition: • [Tiles cracked](#)

**Implication(s):** Trip or fall hazard

**Location:** First Floor Kitchen

28. Ceramic

Recommend repair/replace by qualified person
